28th Creek Road Wetland Delineation Report

28th Creek Road
Carroll Landfill Mitigation Site

Town of Ellington
Chautauqua County, New York

**REPORT SUMMARIZING
THE RESULTS OF
A WETLAND DELINEATION SURVEY OF**

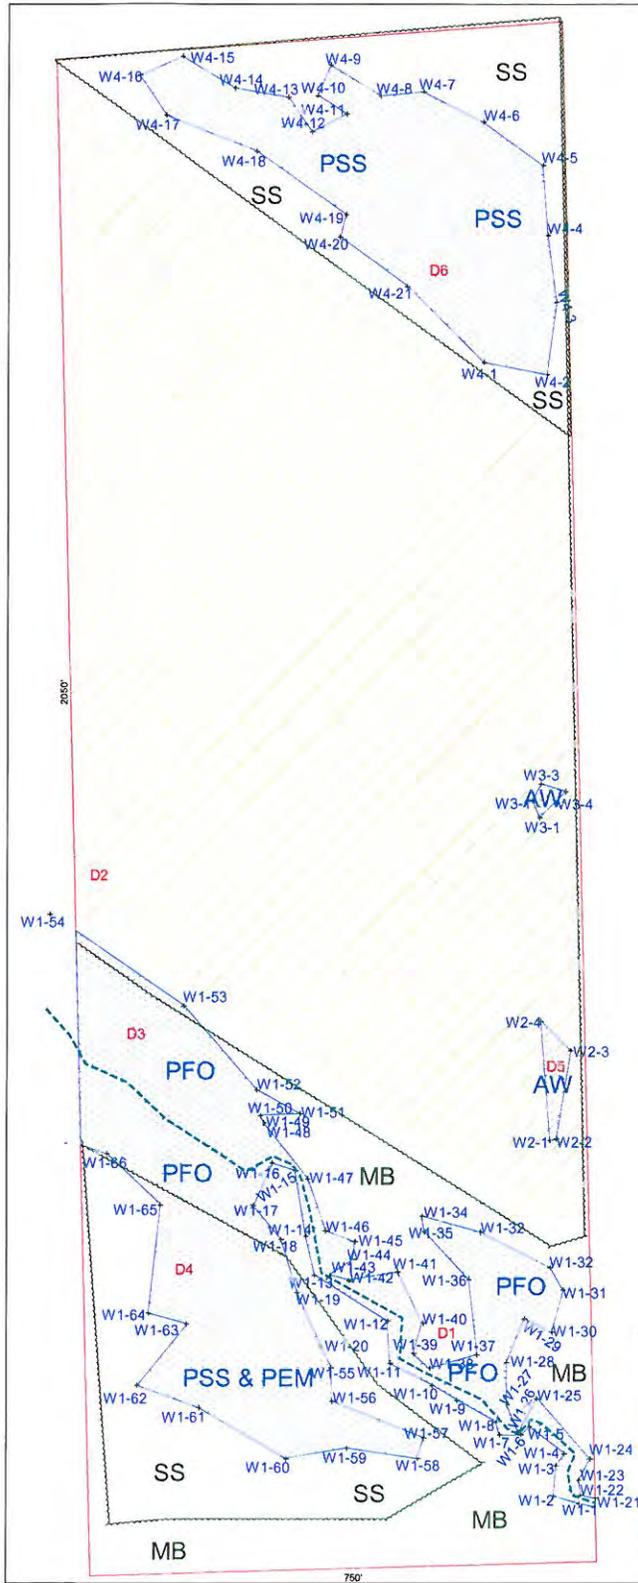
FIGURE 5: General Vegetation Map

A general site map is presented in Attachment A. Figure 5 shows major plant communities found on the property. The uplands within the investigation area consisted of mown hay field, successional shrubland and maple-beech mesic forest communities. The wetland areas were found to consist of forested wetland/ drain, shallow emergent marsh, shrub swamp and shallow emergent marsh (agricultural wetland) communities. The vegetative communities of the investigation area are described according to *Ecological Communities of New York State* (Edinger et al. 2002).

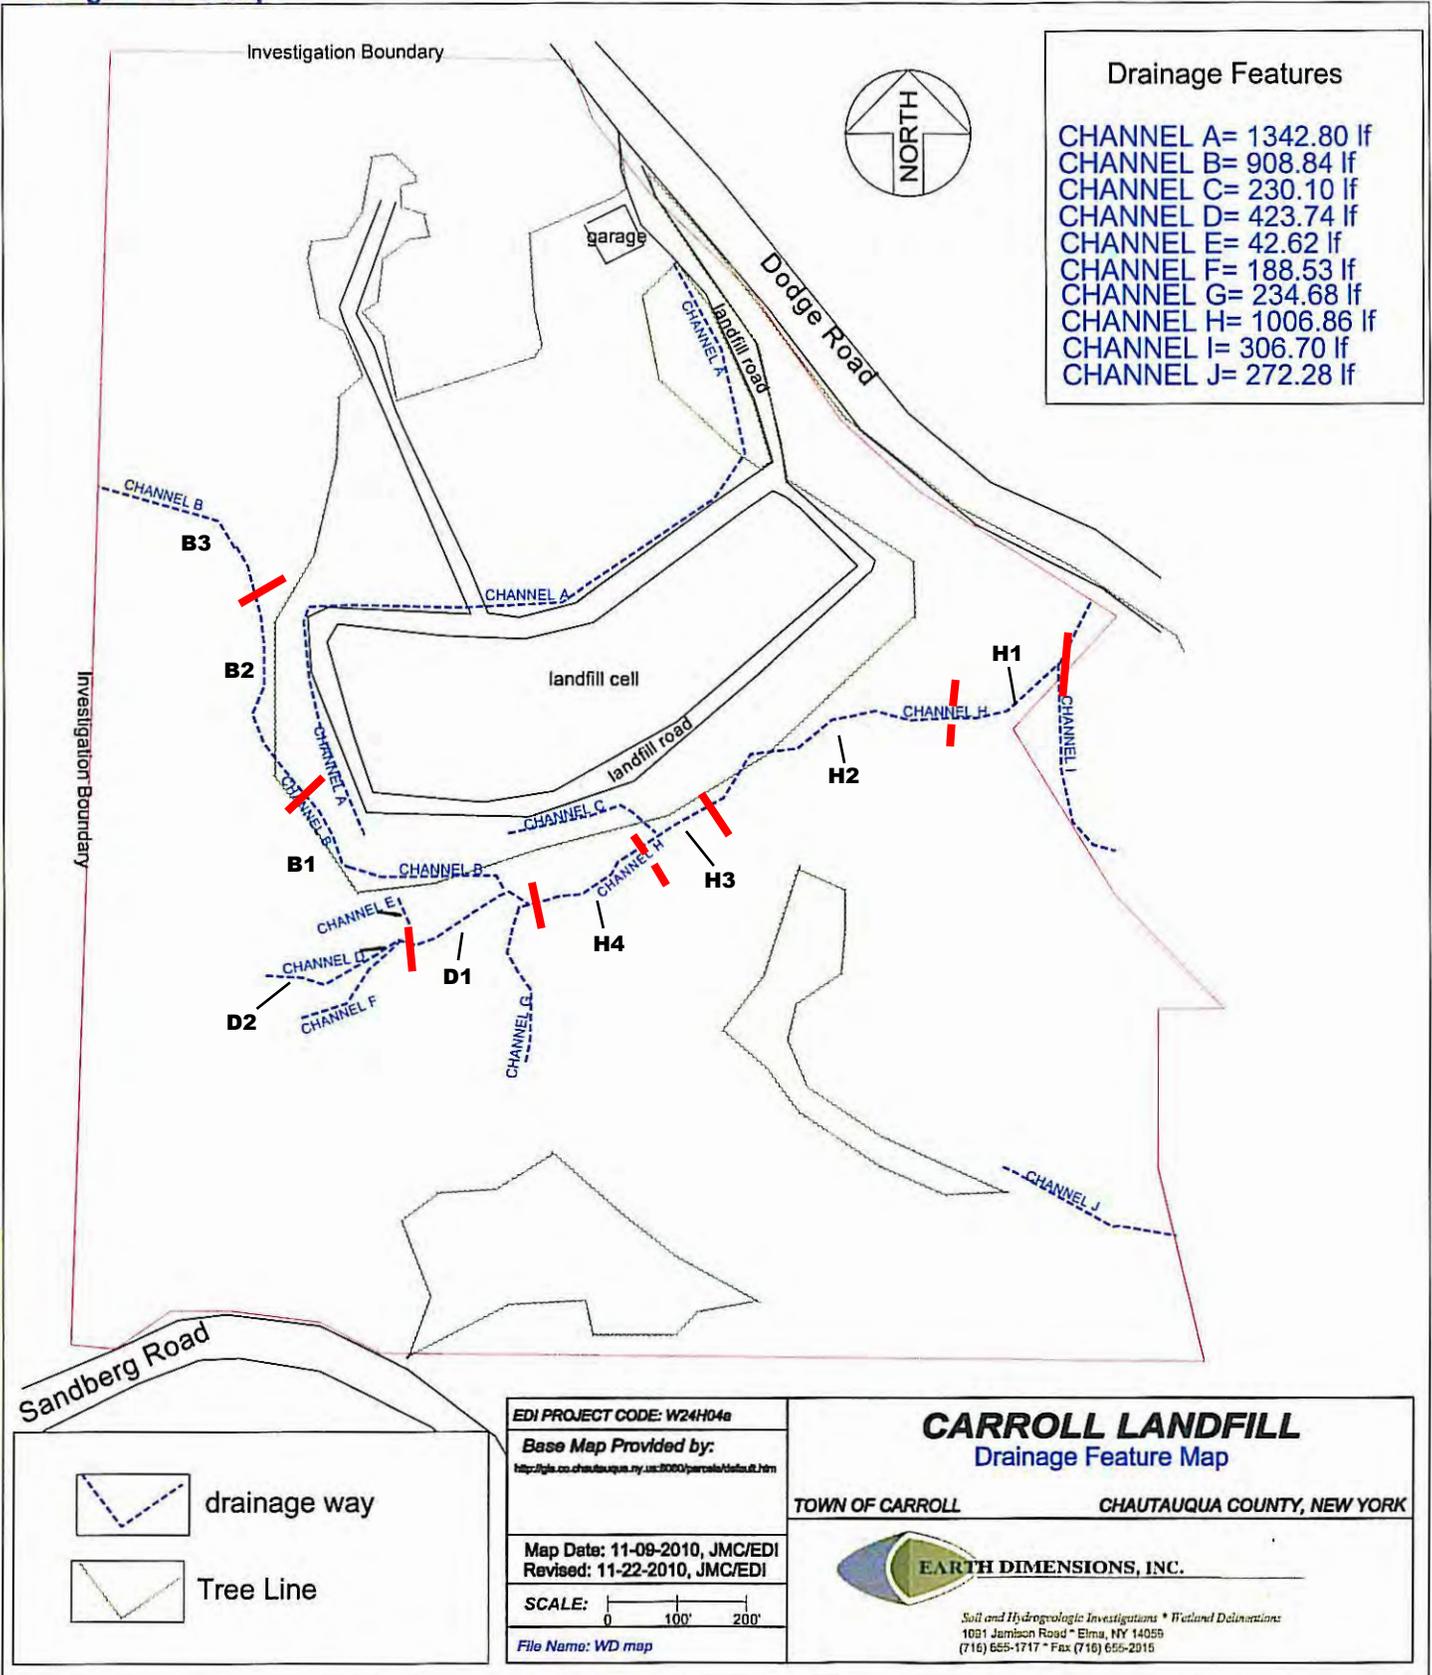
Drainage Feature Map

Figure 1. Location of distinct drainageway channels on the property of the Carroll Landfill, Town of Carroll, Chautauqua County, NY. Channels B through H were assessed using Stream Visual Assessment Protocol Version 2 on April 27, 2016.

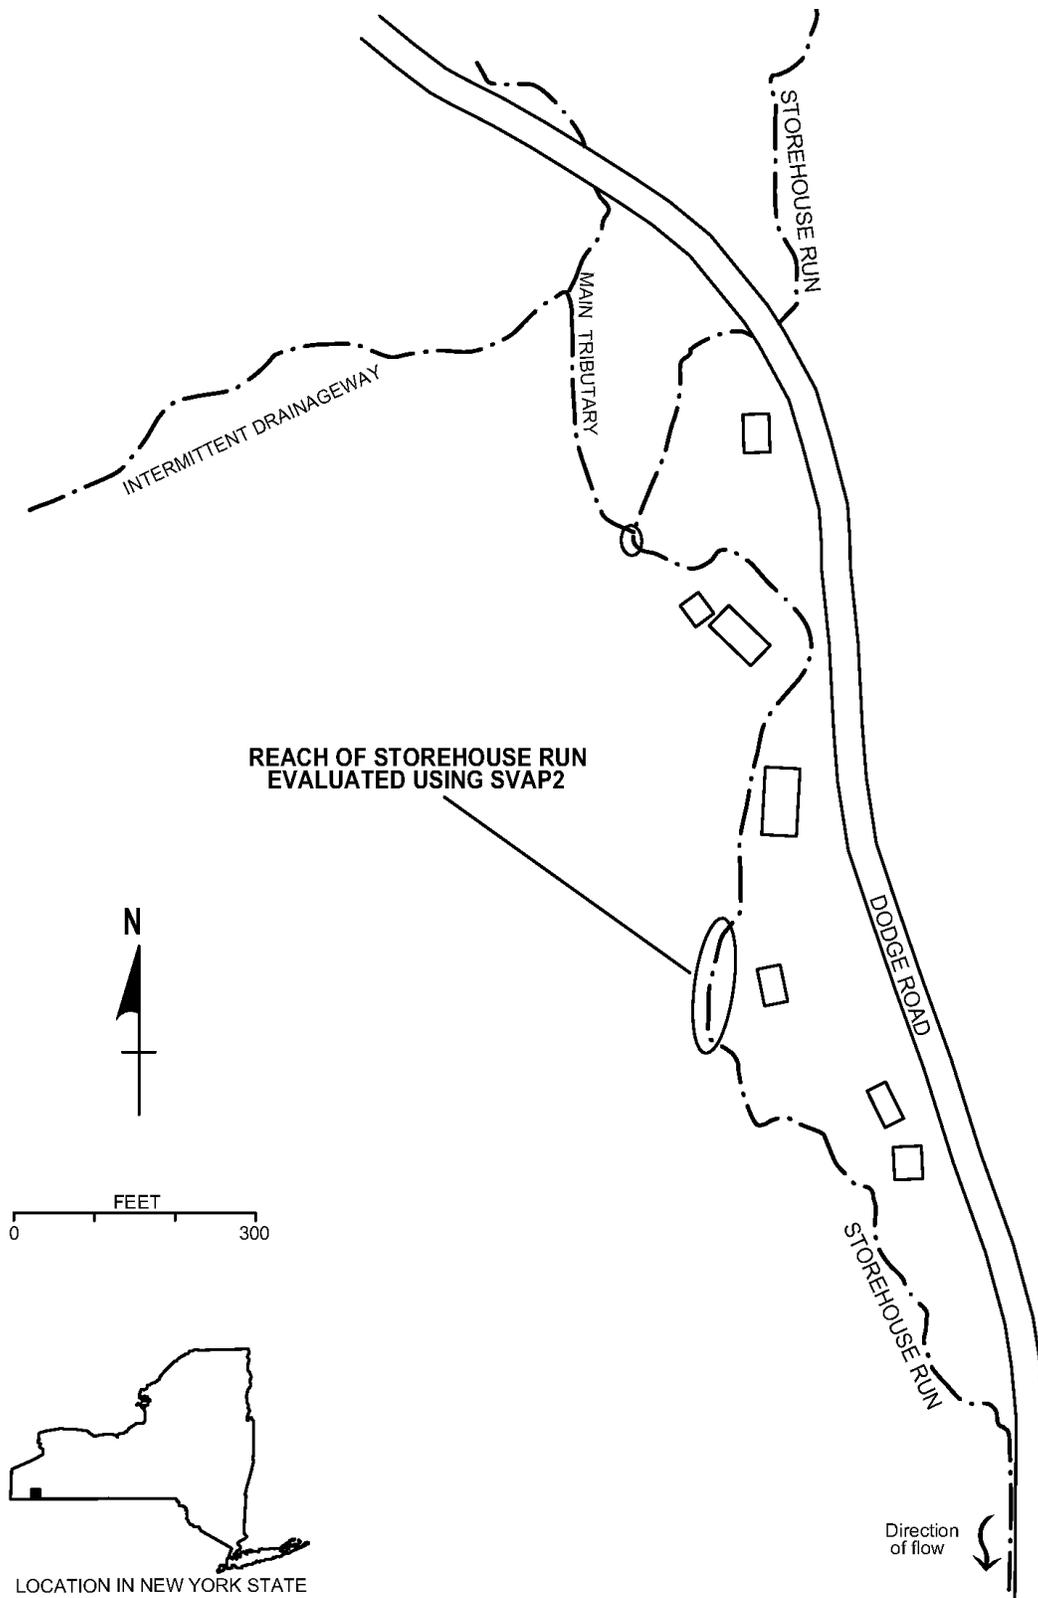
Figure 2. Reach of Storehouse Run in the vicinity of the Carroll Landfill, Town of Carroll, Chautauqua County, NY, evaluated using Stream Visual Assessment Protocol Version 2 on April 28, 2016.

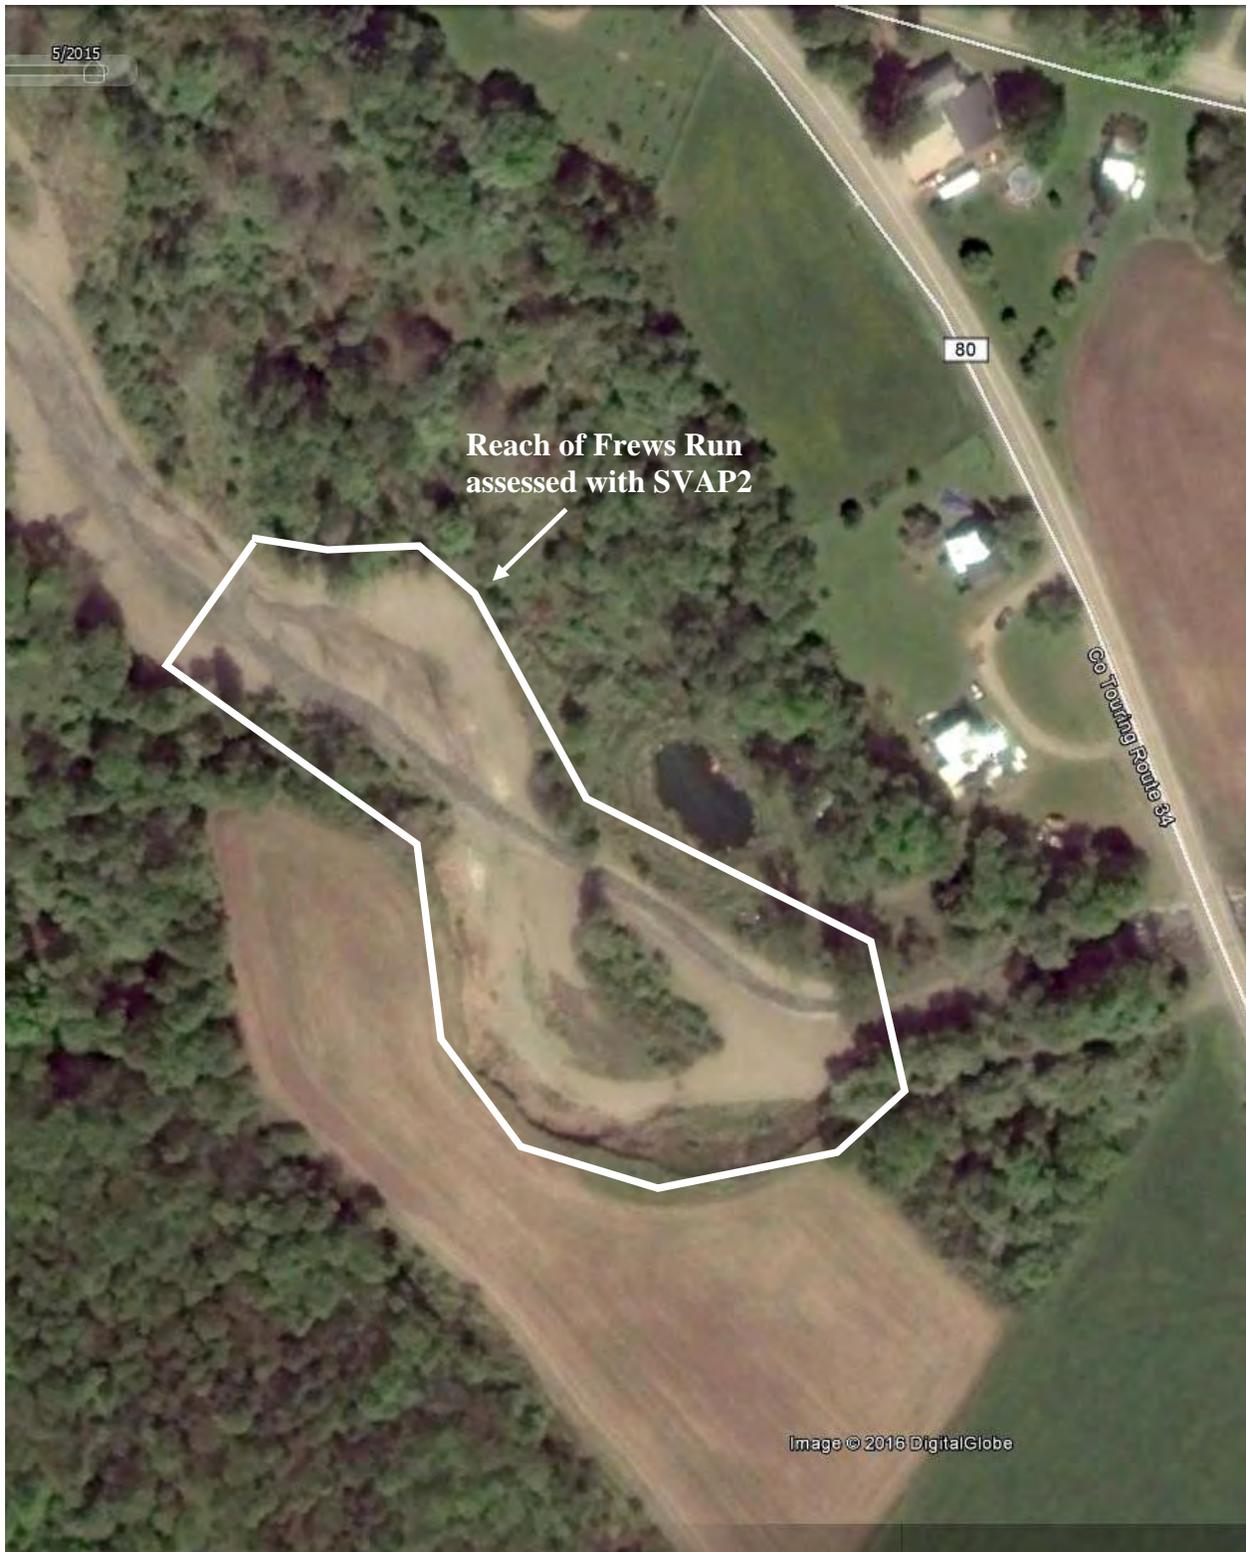
Figure 3. Reach of Frews Run in the vicinity of Frewsburg Chautauqua County, NY, evaluated using Stream Visual Assessment Protocol Version 2 on April 28, 2016.

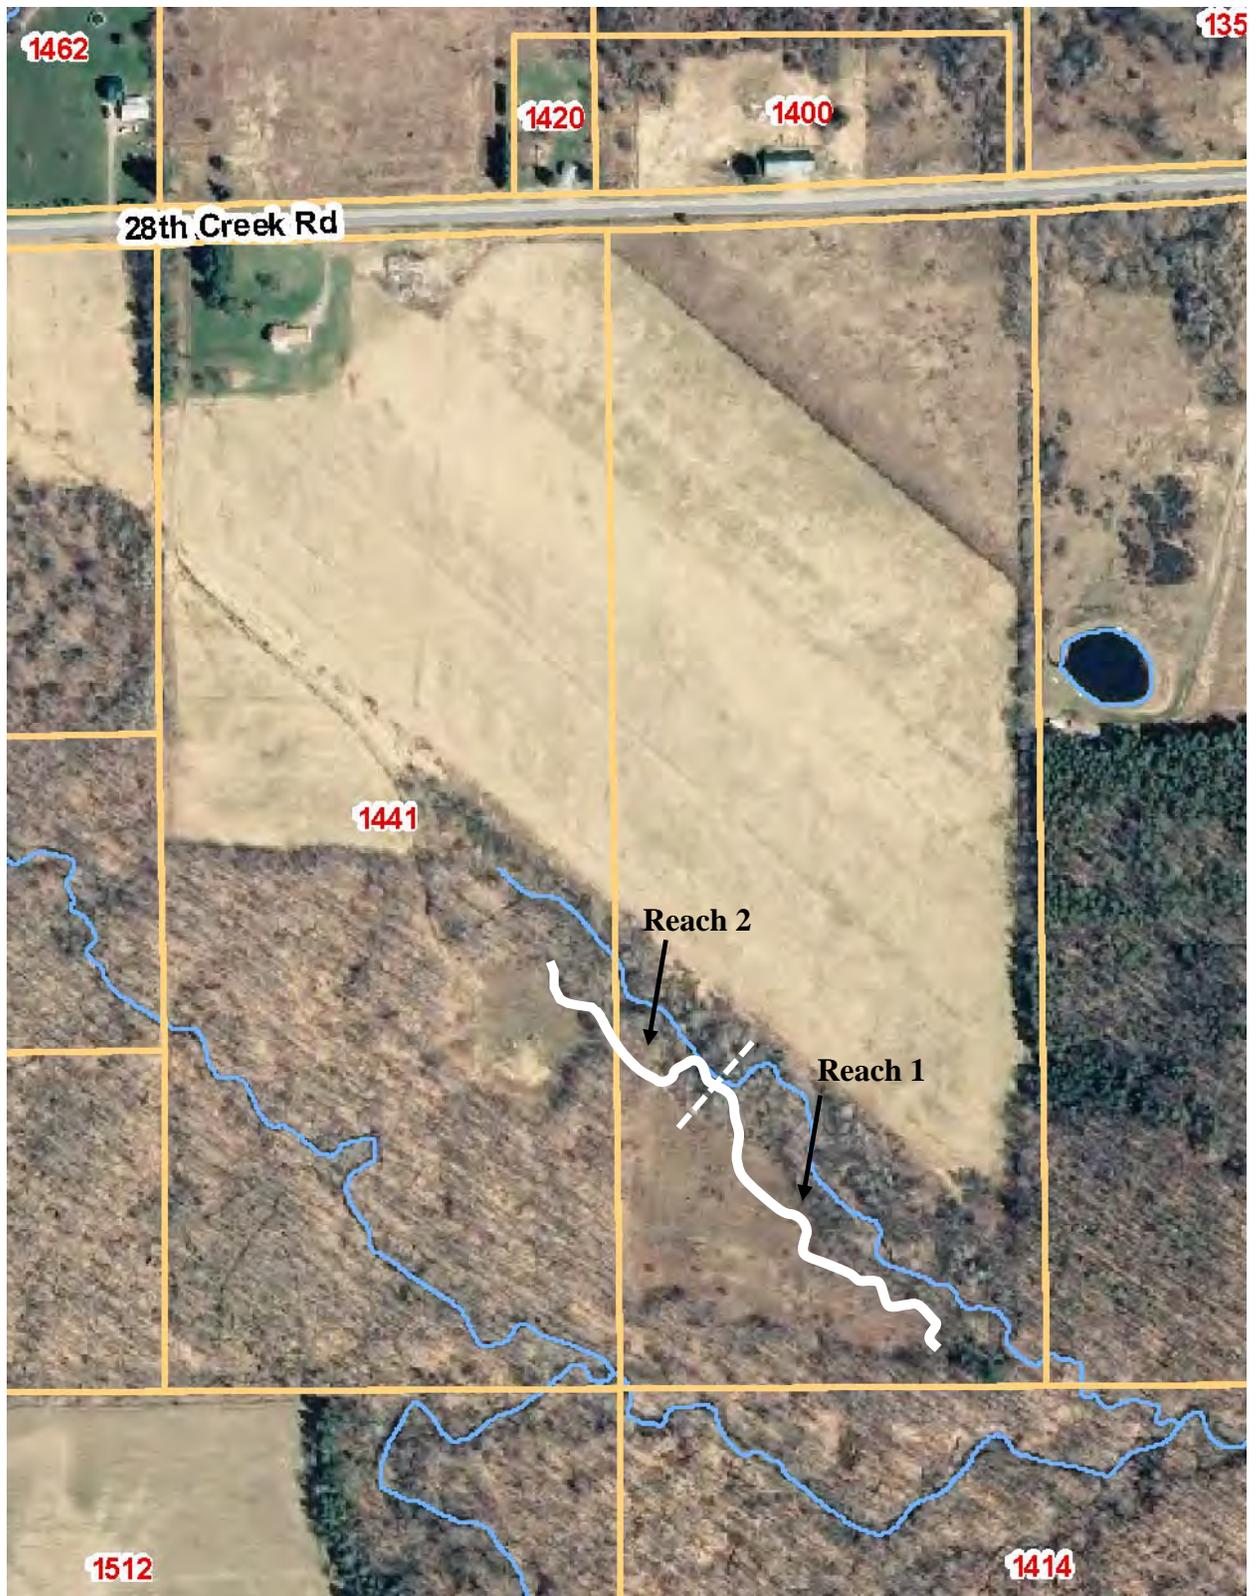
Figure 4. Reaches 1 and 2 of the unnamed intermittent stream near Kennedy, NY, evaluated using Stream Visual Assessment Protocol Version 2 on April 28, 2016.

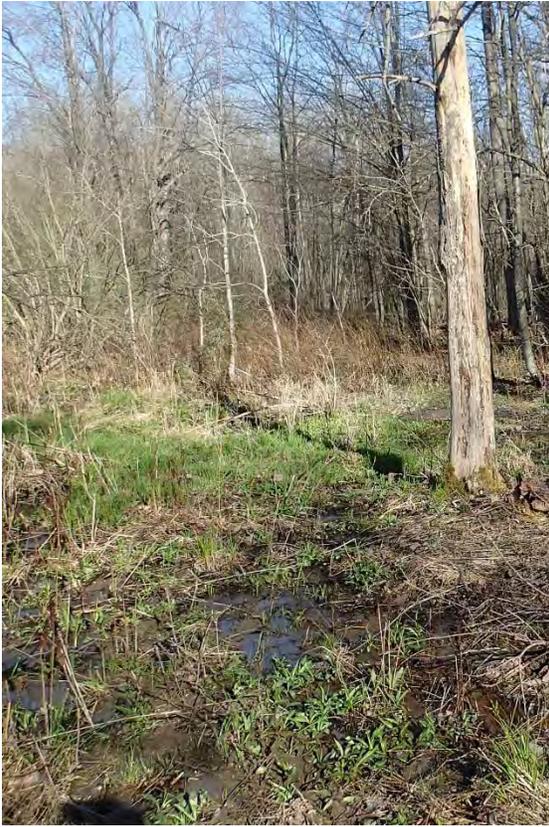
Photo 9. Area of aggrading channel in Channel B1 looking downstream.

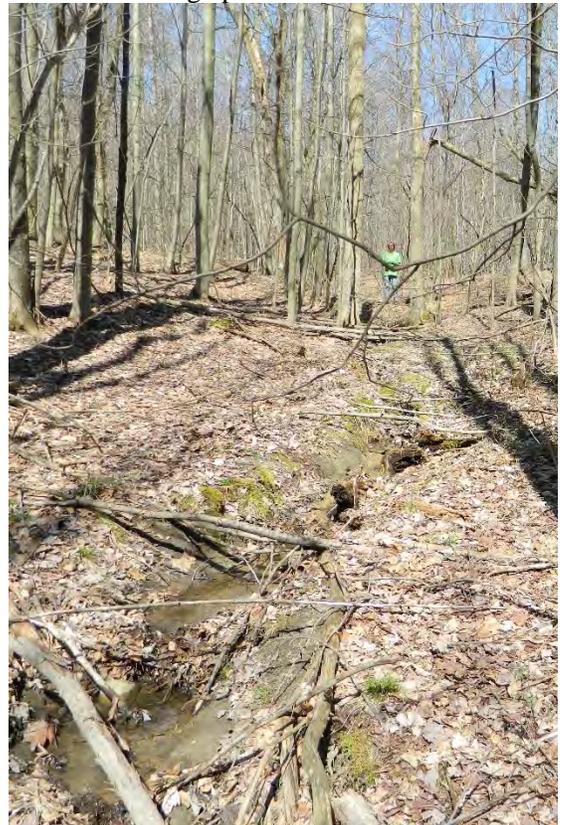
Photo 12. Incised channel in Channel B3 near its upstream end, looking upstream.

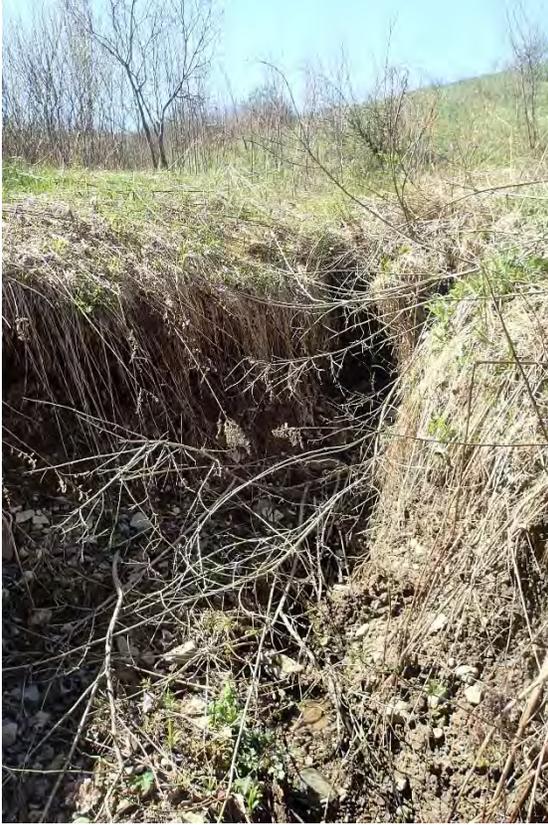
Photo 13. Severe head cut located approximately 75 ft from the downstream end of Channel C.

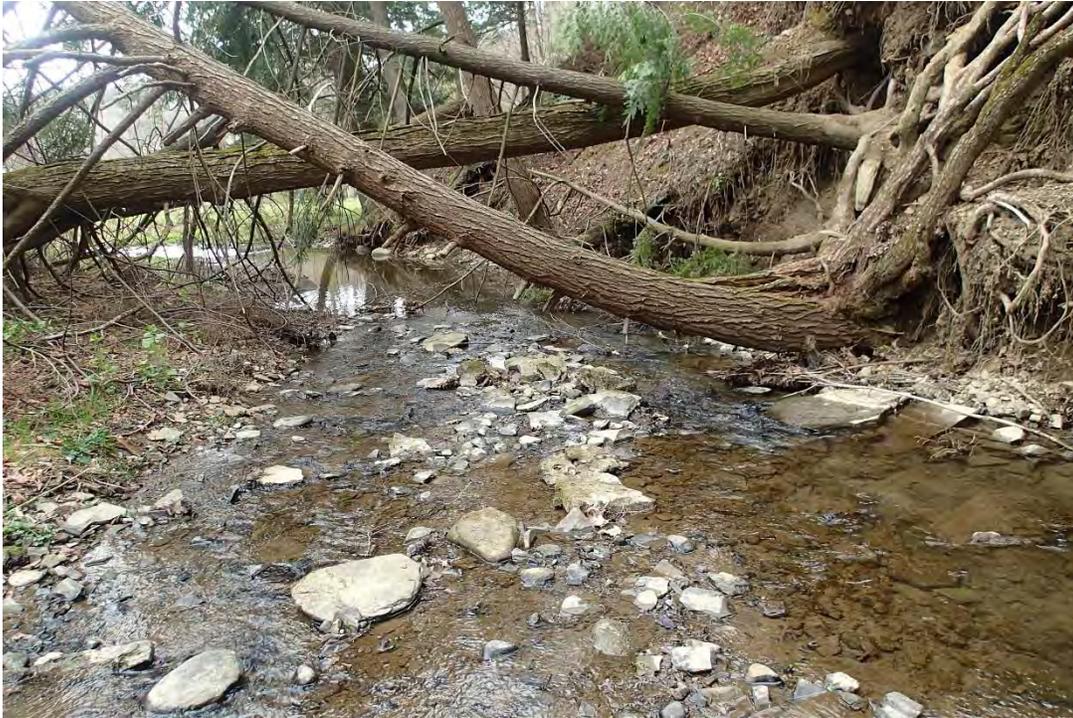
Photo 21. Aggrading channel in the downstream end of assessed reach of Storehouse Run, looking downstream, April 28, 2016.

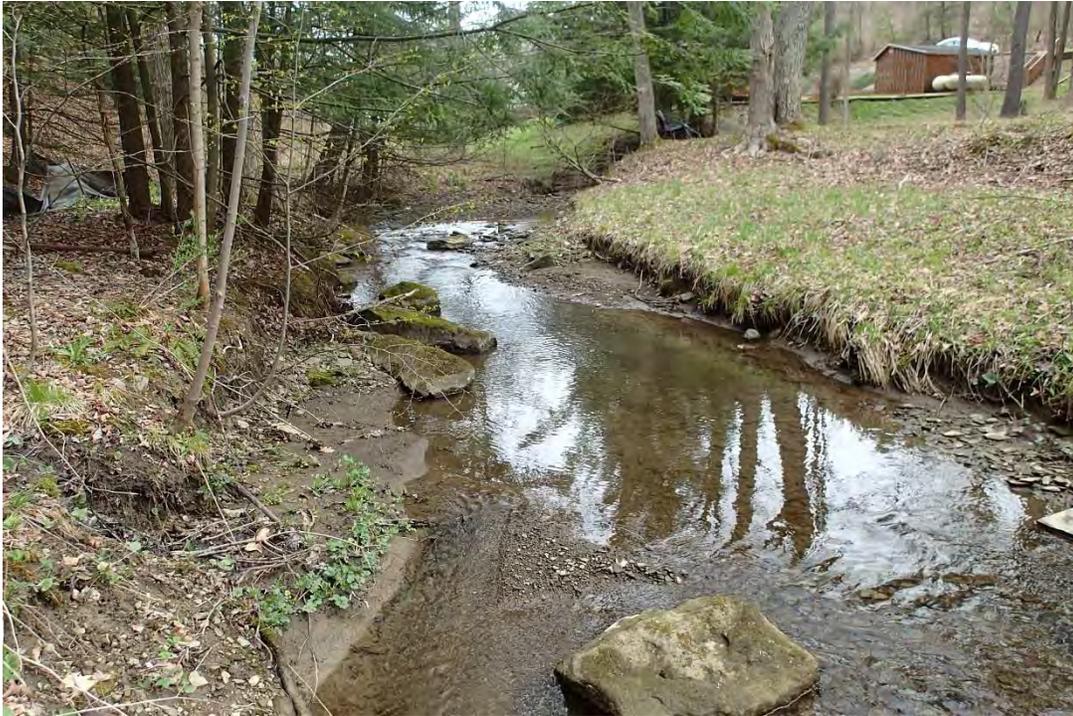
Photo 23. Aggrading channel and shallow pool and riffle habitat in the upstream end of assessed reach of Storehouse Run, looking downstream, April 28, 2016.

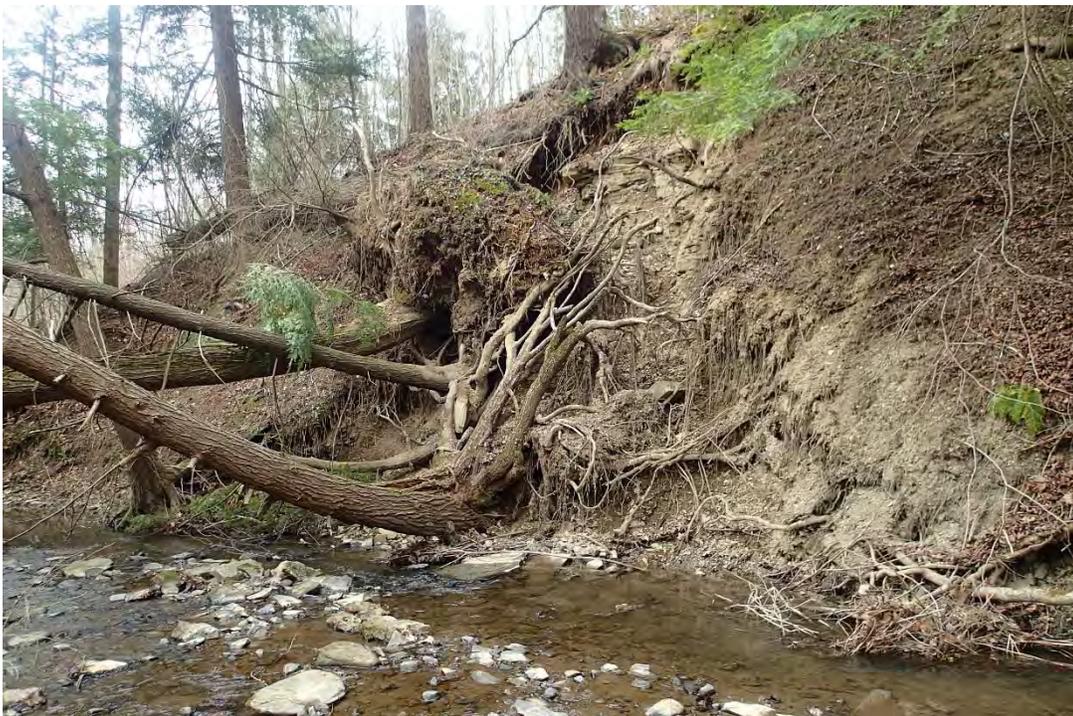
Photo 24. Severely eroding bank on west shore in the downstream end of Storehouse Run, looking downstream, April 28, 2016.

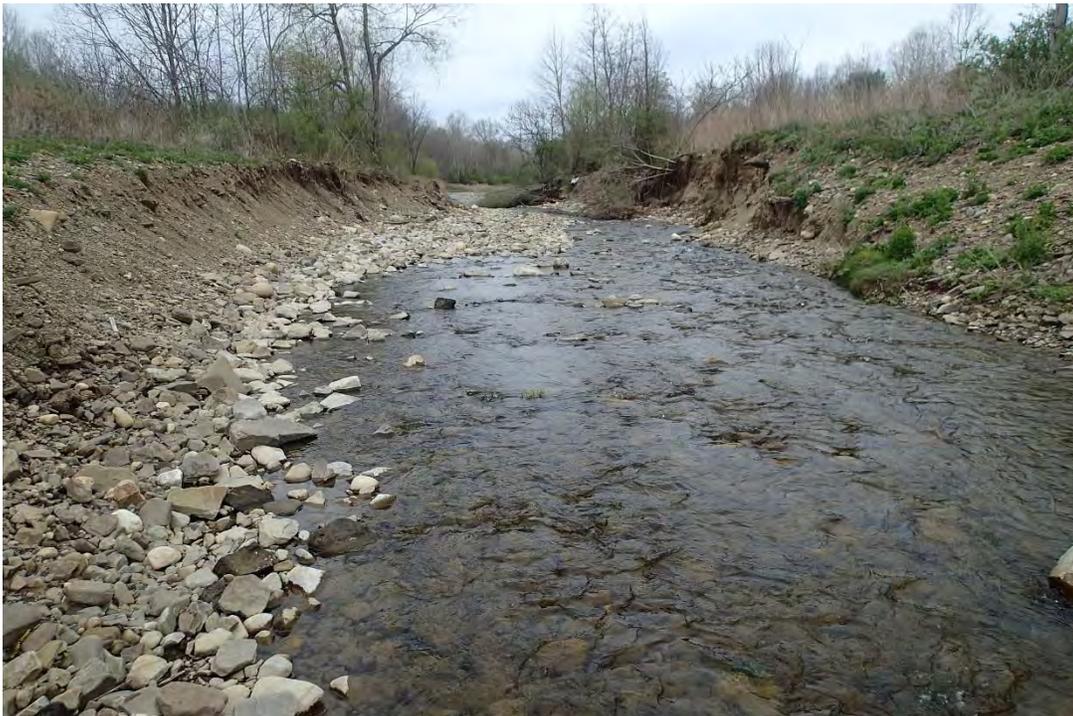
Photo 28. Severely eroding banks in the mid-section of the assessed reach of Frews Run, looking downstream, April 28, 2016.

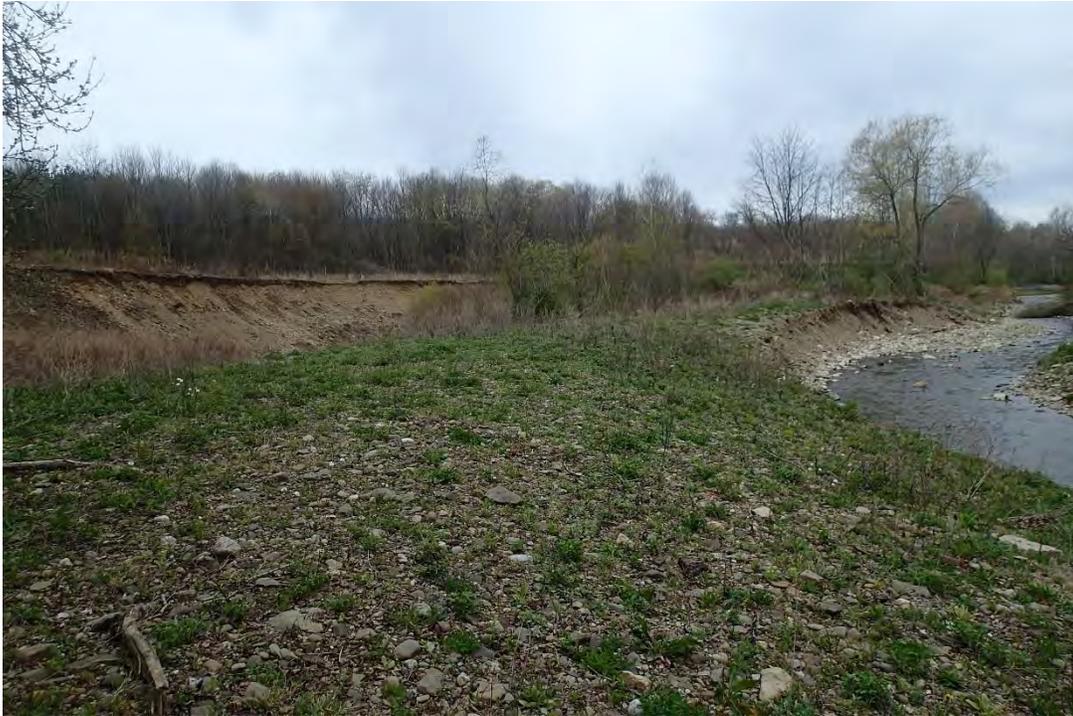
Photo 29. Denuded riparian zone and high eroding bank along the left side of the assessed reach of Frews Run, looking downstream, April 28, 2016.

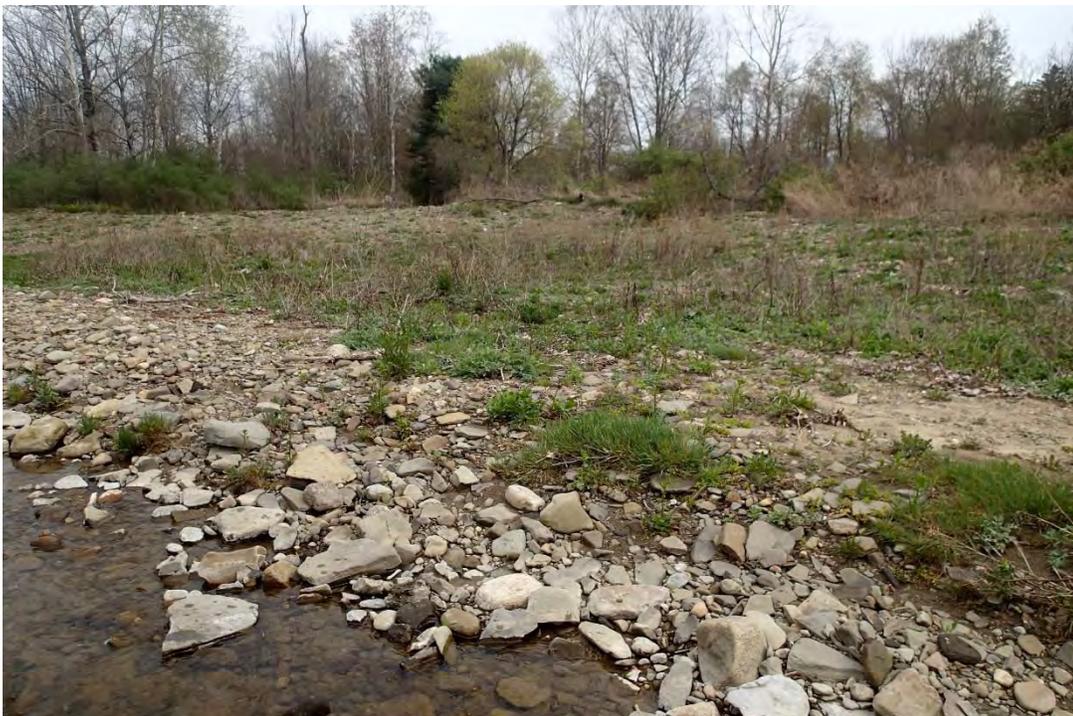
Photo 30. Denuded riparian zone near the downstream end of the assessed reach of Frews Run, looking east, April 28, 2016.

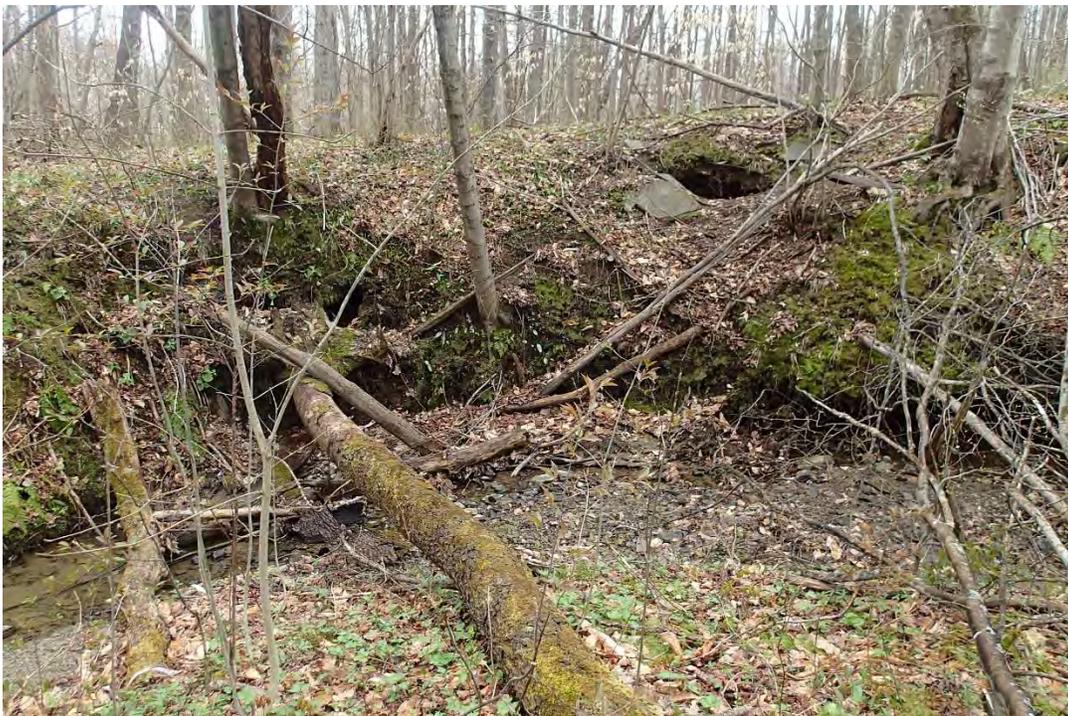
Photo 34. Evidence of bank undermining and trees falling into the channel of Reach 1 of the unnamed stream near Kennedy, NY, looking upstream, April 28, 2016.

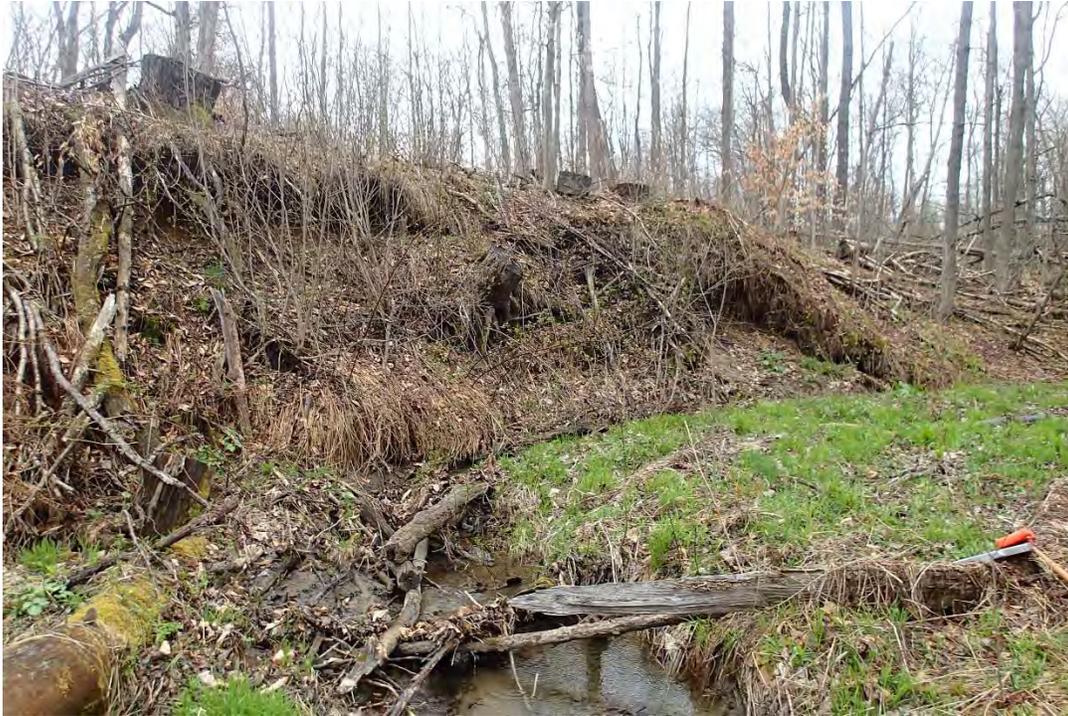
Photo 35. Evidence of riparian zone logging and degradation in Reach 1 of the unnamed stream near Kennedy, NY, looking upstream, April 28, 2016.

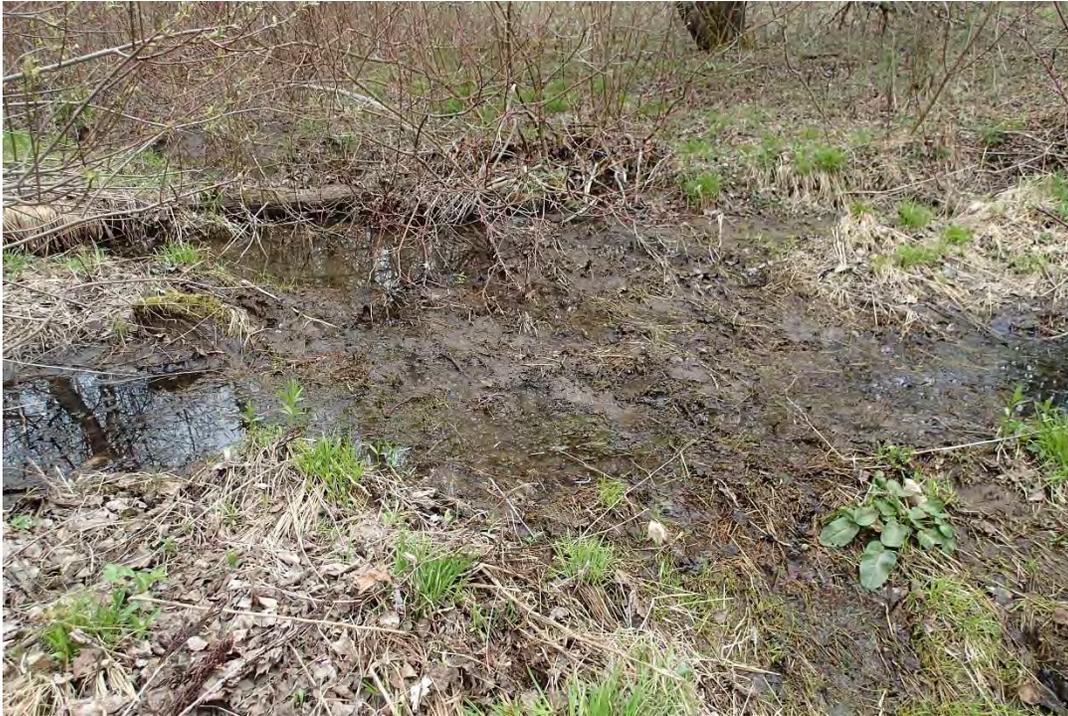
Photo 37. Old logging or farm road crossing in Reach 2 of the unnamed stream near Kennedy, NY, looking upstream, April 28, 2016.

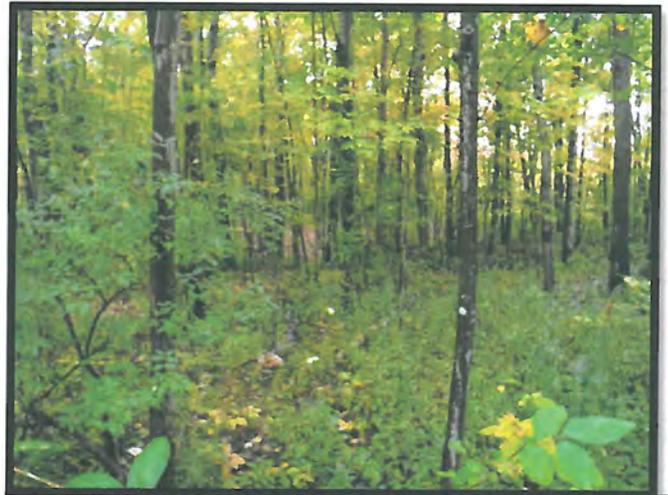
Photo D2; Facing Southwest. Depicts successional northern hardwoods.

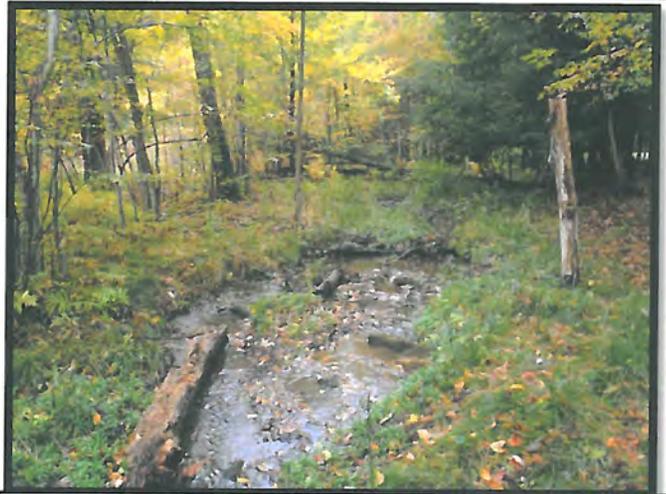
Photo D4; Facing North. Depicts Wetland 1, floodplain to Storehouse Run.

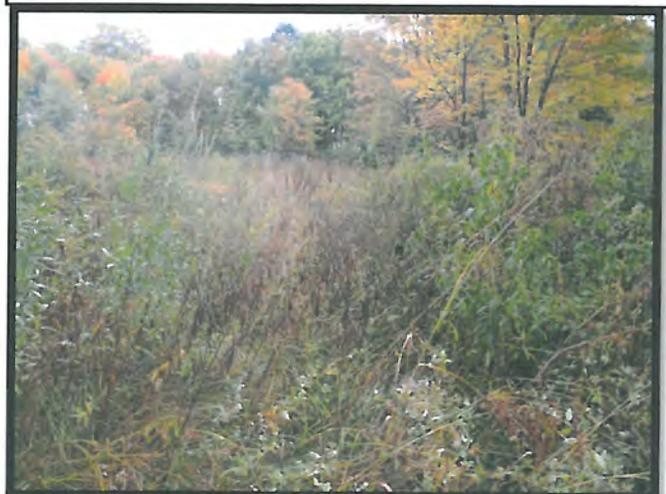
Photo D6; Facing Northwest. Depicts Wetland 2.

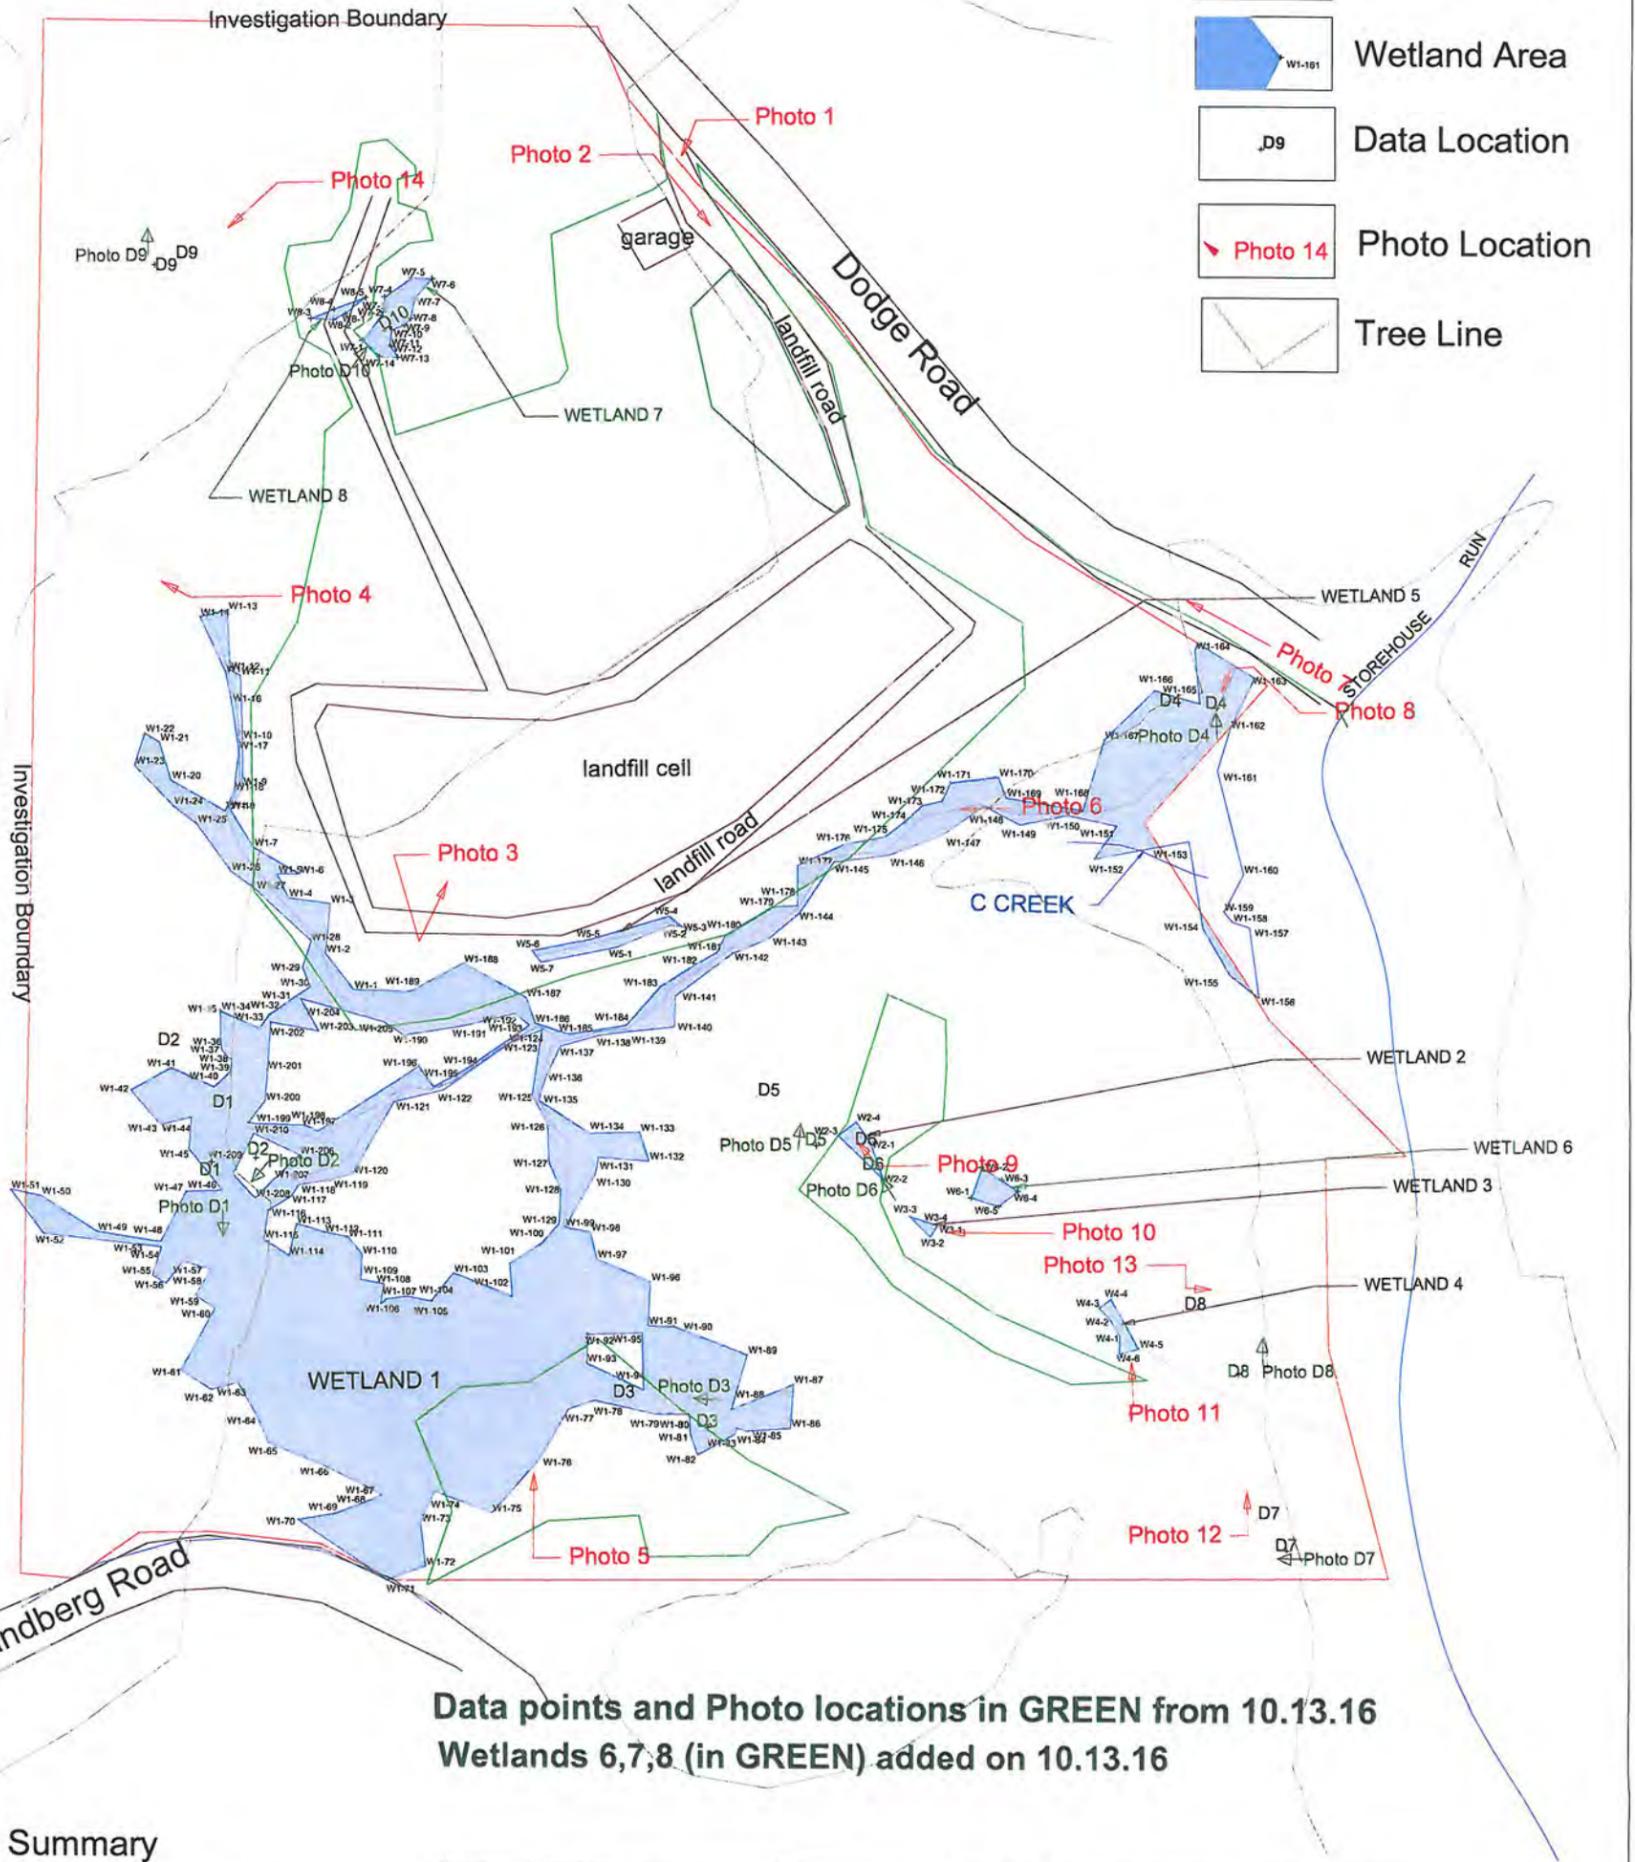
Data points and Photo locations in GREEN from 10.13.16
 Wetlands 6,7,8 (in GREEN) added on 10.13.16
